# Church safety solutions

April 2007

## Peeling the layers off roof damage

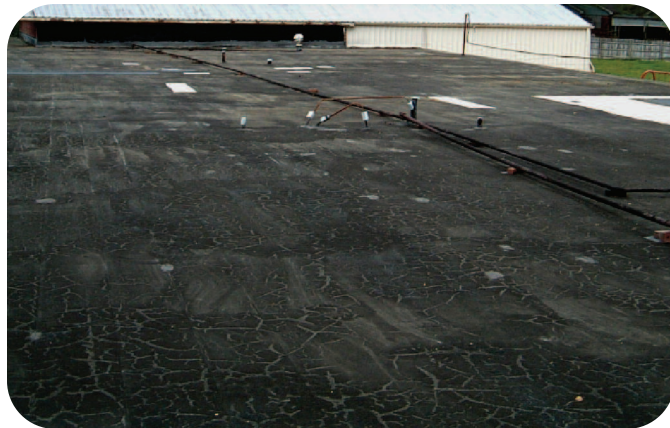
**Alligatoring** is the deterioration of the roofing surface due to age. The roofing surface loses its elasticity and begins to look like cracked leather. A licensed and insured contractor should repair this type of roof

The roofing surface loses its elasticity and begins to look like cracked leather.

damage as quickly as possible, because it is likely the surface of the roof will no longer keep water off the under-layment and begin to rot the roof deck and joists.

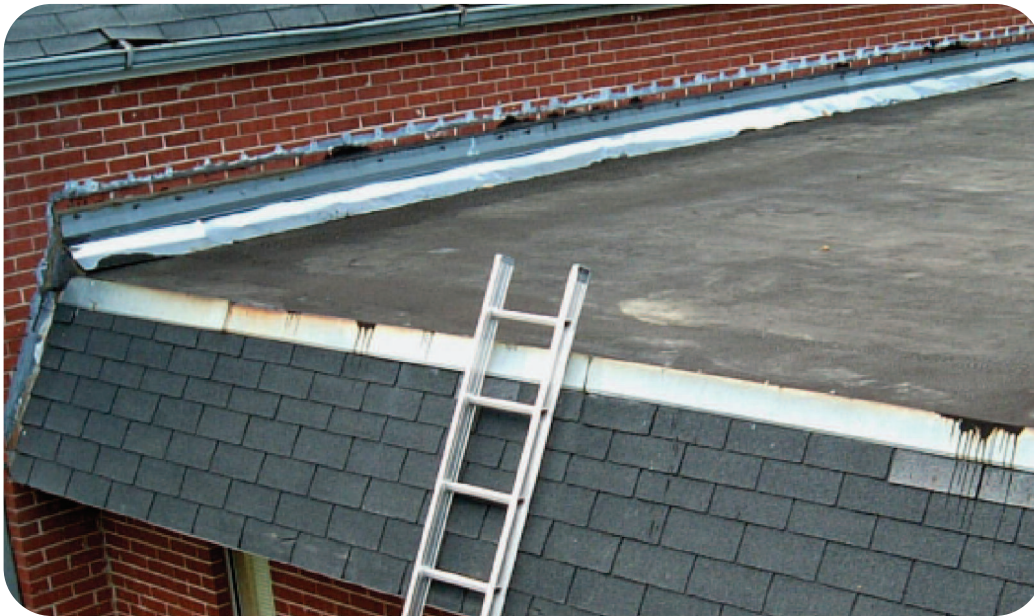
Other common areas of concern result from flashing being damaged or torn away. When roof flashing becomes damaged, it will permit water to leak under the roofing material.

When roof flashing becomes damaged, it will permit water to leak under the roofing material.

- Don't forget to look at roof flashing during roof inspections. Damage to roof flashing is one of the most common forms of damage, permitting water to leak under the roofing material.

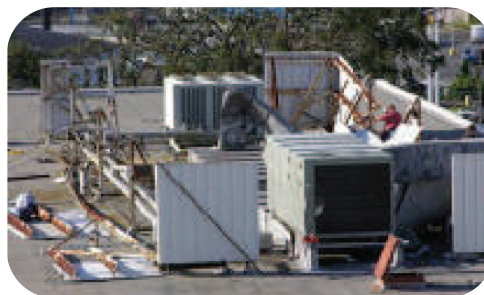
Several of the equipment screen panels were blown away. Loose panels can break glazing and puncture roof membranes.

Rooftop equipment can become detached during high winds. Water can then enter the building at the openings left by the displaced equipment. The displaced equipment can then blow around the roof structure and can puncture and tear roof coverings, allowing additional damage to occur from water leaking into the building, further impacting a church's ability to further their ministry.

A licensed roofing contractor can provide advice about how to secure rooftop equipment so costly damages can be avoided.
